Inspection Report

123 Main Street
Helena, MT 59601

Ascension Home Inspection

Date: 9/7/2007	Time: 1:00 PM	Report ID: 70907
Property: 123 Main Street Helena, MT 59601	Customer: Mr. Robert Zimmerman	Real Estate Professional: Tom Landry

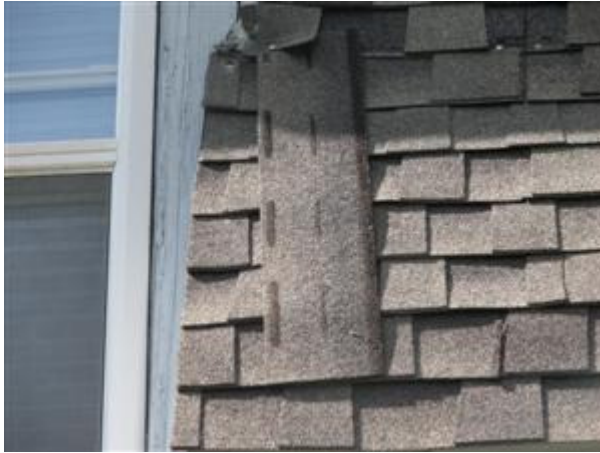
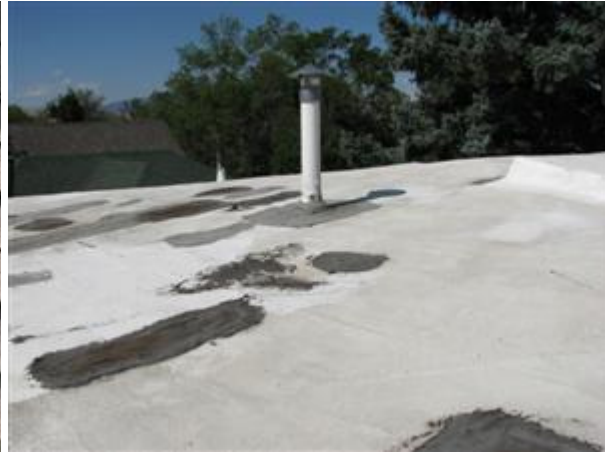
- 1. This is a Mansard style roof with two different roofing materials. The architectural shingles are in good condition however, it appears that this may have been a nonprofessional installation.
- 2. There is one strip of shingles on the ground on the east side of the house, one strip is hanging by one nail. These should be replaced.
- 3. The upper roof should be watched. There are numerous patches and many hairline cracks. I recommend having the roof system evaluated by a licensed roofing contractor.

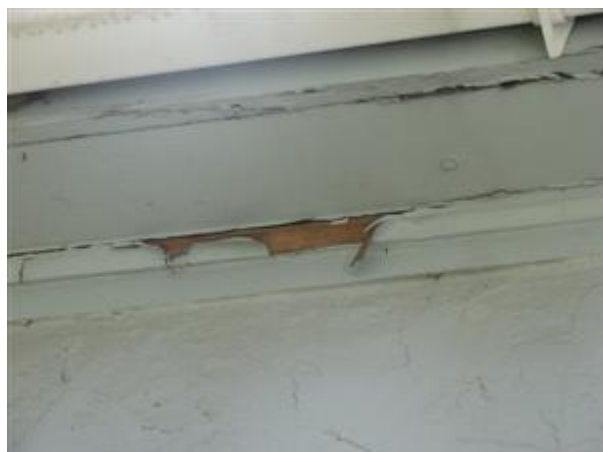
2.1 Picture 1

Paint should be maintained so further deterioration does not occur.

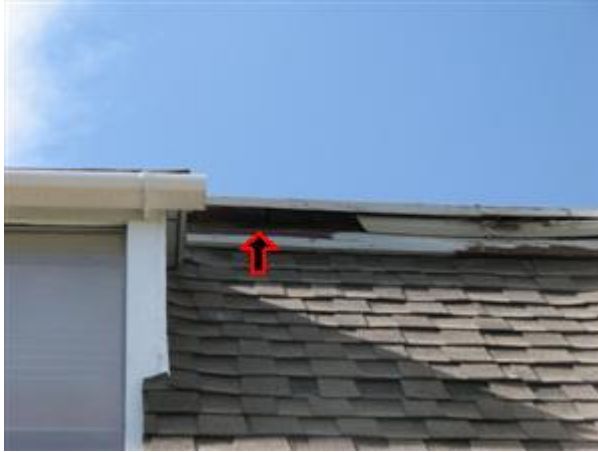
The fascia board is in rough shape. There is spray in foam filling some holes. There are chunks missing from numerous section and wasp nests were observed. Covering or filling holes in the short term would be a good idea. They are nearing the end of their life . Budget for replacement.

2.4 Picture 1 Missing piece of fascia board

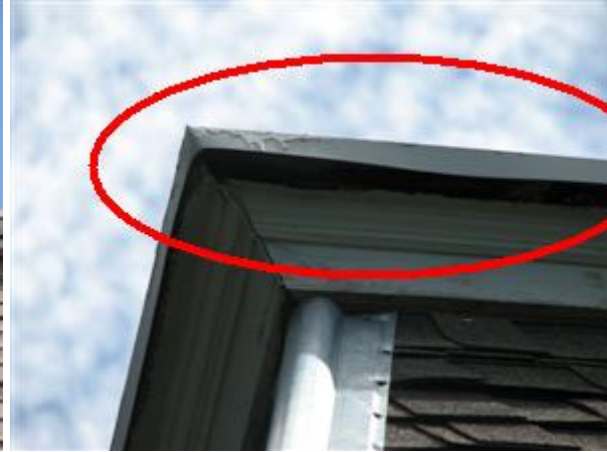
2.4 Picture 2 Typical fascia deterioration

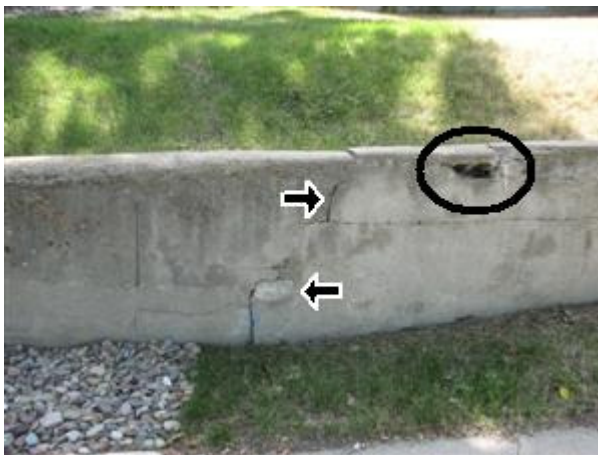
Retaining wall on west side of the property is marginal. Your neighbor portion is in worse condition but, this will effect your side. There is spalling and one big piece of concrete missing from the front steps from sidewalk. Do not use salt in the winter.

2.7 Picture 1 The main crack is close to what the property boundry is.

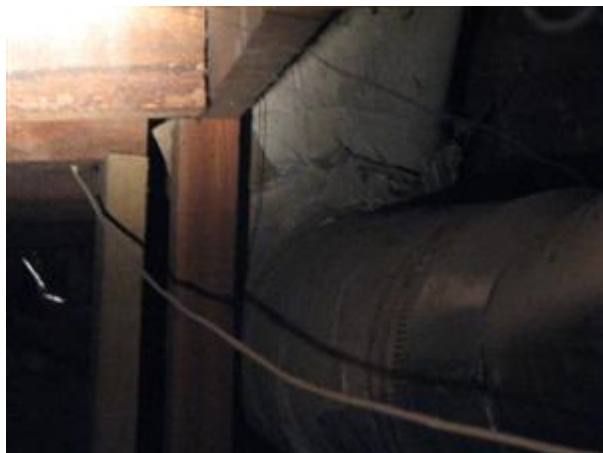
The original floor structure is holding up. There are not considerable, noticeable sags in the floor from above. However, this vintage of house did not allow for ducting to penetrate the floor system. When ducts were added the floor was cut and was not properly headed off. The floor system has make shift supports under these areas. Watch these areas. Dry stacked rocks and shims are not a permanent solution.

5.3 Picture 1 Cut joists and ducting

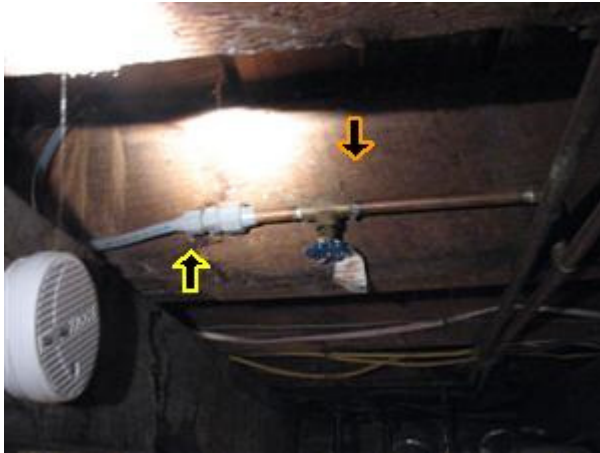
- the inside of the pipes over time. This will be an item that eventually will need to be upgraded.
3. The joist bay that the hot water heater is in has a pipe that that is leaking at a junction adjacent to shutoff.

6. There is at east one section of Polybutylene piping near the hot water heater. This particular material has readily known deficiencies and a class action suit against the product. Have the plumber evaluate this component when he is looking at other system defects.

7. The hose bib had a hose attached to it. When the hose was removed to test for water pressure a leak was identified. The valve is defective and should be replaced. Contact a licensed plumber to evaluate and correct system problems.

6.1 Picture 1 Poly pipe and on the right is the leak.

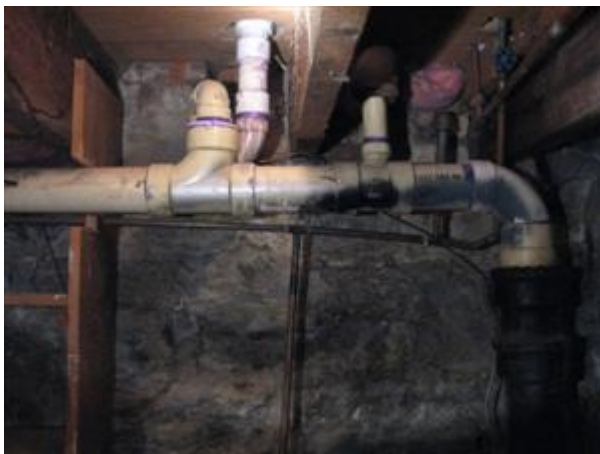
- 🏠 S trap in downstairs bathroom should be replaced with P style trap. Also improper trap in the basement. Given the issues uncovered during inspection a licensed plumber should evaluate the system and make recommended repairs.

6.3 Picture 1 Negative fall

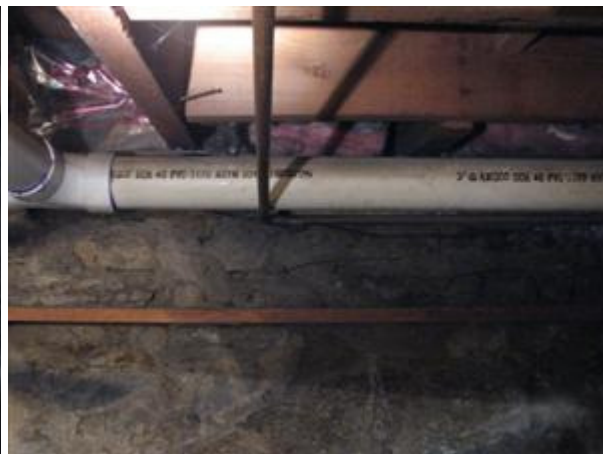
6.3 Picture 2 Pipes resting on top of each other

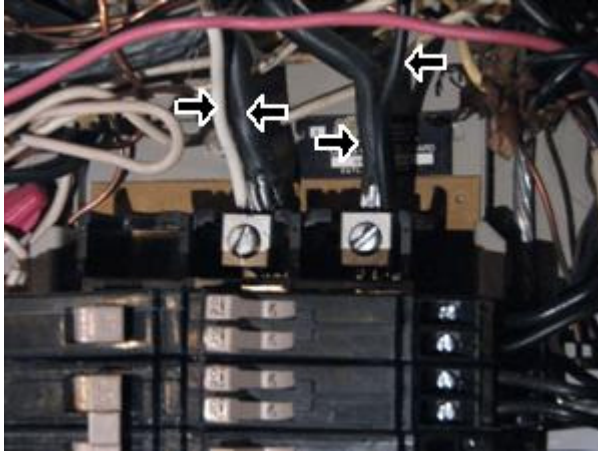
2. There is a free floating romex wire in the garage sub panel. This should be corrected by a licensed electrician.
3. There were at least two double taps in the distribution panel. This presents a fire hazard and should be corrected by a licensed electrician.
4. Antioxidant paste was not noted on the aluminum feed to the main panel.
5. Have this system evaluated, there are numerous issues.
6. Circuit in the downstairs entry area is not working or not turned on. No thrown breakers were encountered in the distribution panel.

7.3 Picture 1 Double tapping

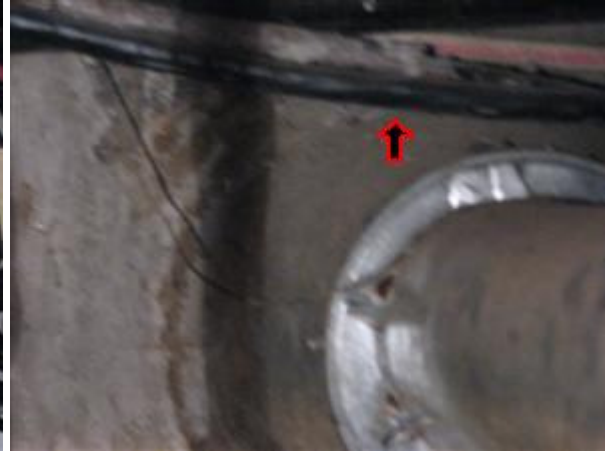
in operation for 10 minutes. The flue was well above 120 degrees. This is a major safety concern. If that cable's sheathing is compromised it could energize the ducting of the house.

7.3 Picture 2 100 amp cable resting on exhaust furnace pipe collar

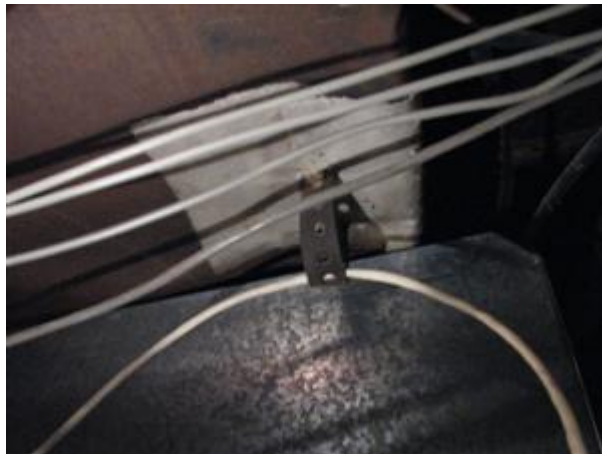
- 1. **There are multiple sitings of asbestos like looking material in the ducting system. They include remnants of tape, and connectors. The more troubling issue is that some of these materials are used in systems that are active. Air being distributed over the material is being distributed through the house. This is potentially a significant safety hazard.**
- 2. There are numerous issues with the ducting. Many of the supports are missing or inadequate. Ducting is resting on top of other systems such as plumbing distribution in some instances. This item should be fixed.

8.3 Picture 1 Asbestos like tape

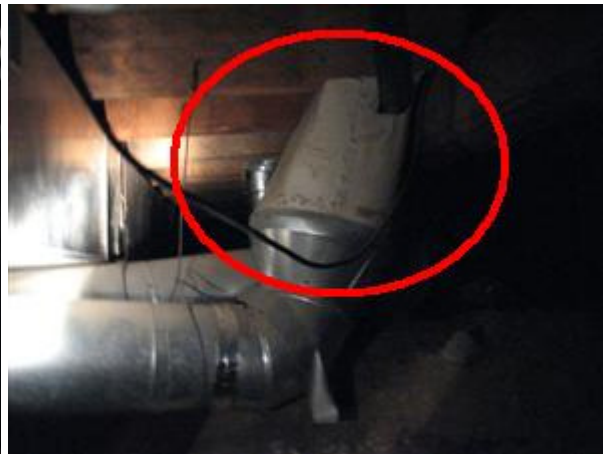
8.3 Picture 2 One example of asbestos like duct compent
